**UNIT 1 - SPRING, 1989, OUTAGE
ENGINEERING INSPECTION REPORT**

STEAM GENERATOR - BURNER INSPECTION

OBSERVATIONS AND WORK ACCOMPLISHED

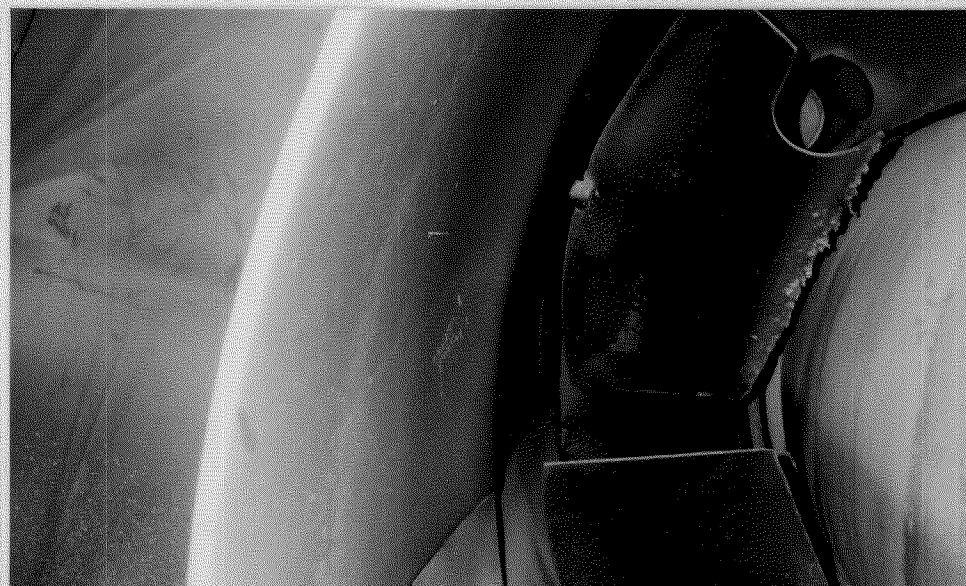
Photo 15 - Inner air sleeve showing overheating and expansion with rippling along seam weld (Burner 1E05).

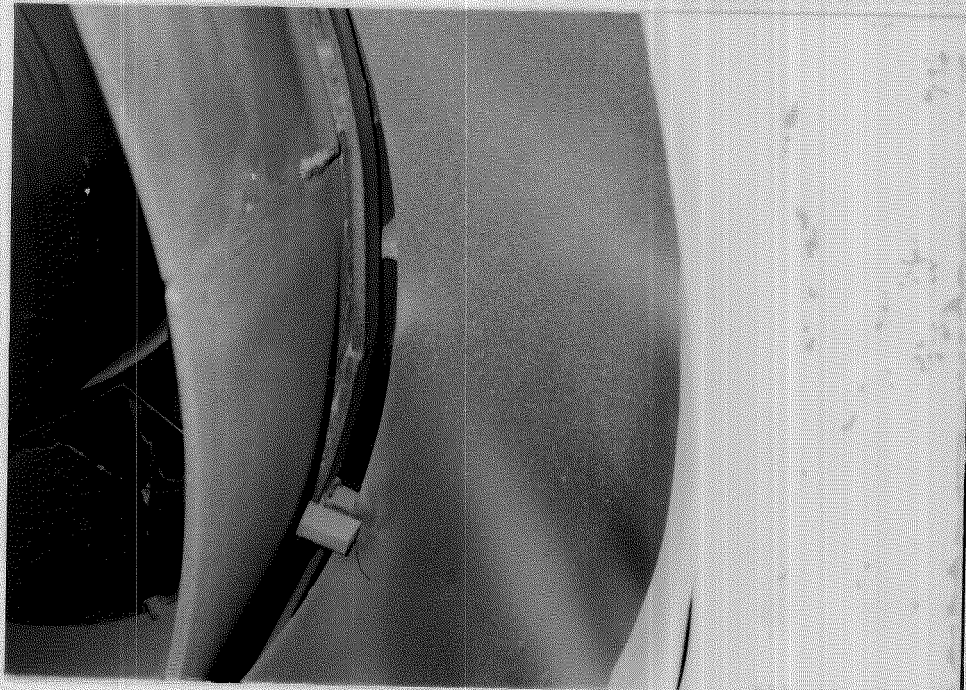
Photo 45 - Excessive clearances around the inner air sleeve where the outer air register assembly has been cut free to allow thermal expansion.
